The Electrical Expert
Forensic Analysis & Expert Witness

SUBJECT: CAUSATION CALIFORNIA WILDFIRES
RESPONSE TO YOUR EMAIL DATED 11/30/2018

The following Exhibits are examples of what you, the CPUC AND CAL FIRE know and to my knowledge have INTENTIONALLY DIREGARDED:

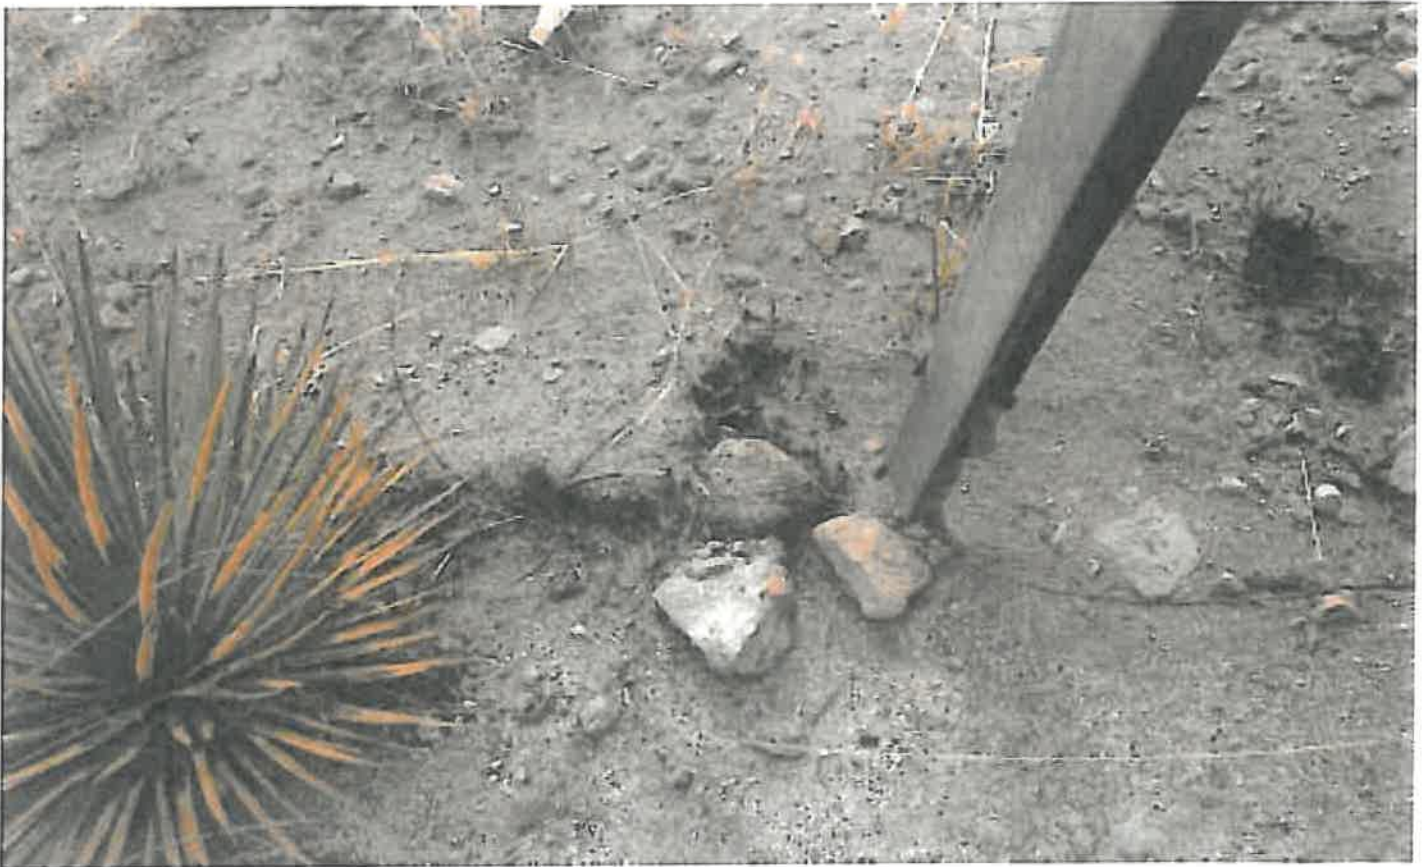
START OF Witch FIRE !!!!

Exhibit "A" Picture of Where the Witch Creek Fire started. Provided to CPUC in 2008. Note the burn pattern leaving a down guy anchor on transmission line TL 637

The following questions the public should ask, once you realize these pictures show uncontested proof of burning, and arcing at ground level with flammable dry grass. The pictures are self explanatory and easy to understand. The pictures are supported with lab results from samples taken by two independent Arson investigators, Mr. Robert Reinhardt and Mr. Brad Phillipson, both certified fire investigators and former fire captains. Ed Clark had site visits showing members from the California Public Utilities Commissions and Cal fire where the pictures were taken and explained how the fires started!

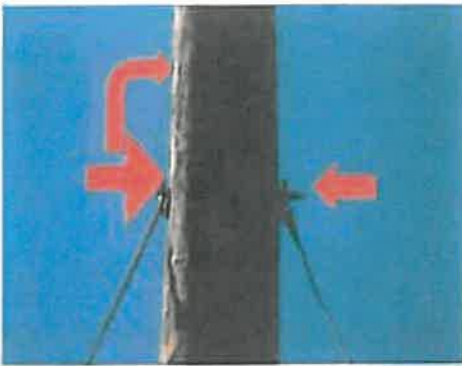
Down Guys Attached at the Same Point :
"WRONG"

- a. Two down guys attached at the same point on the pole
- b. The cause of that design shows arcing at the connection point and dry grass in the same location.
- c. The Lab Reports provided to both the CPUC and Cal Fire in 2008 were performed by an independent party verifying the arcing is caused by electricity.
- d. The black marks inside the yellow covers is carbon residue caused by electrical arcing and the source of the sample taken to a third party lab for testing.

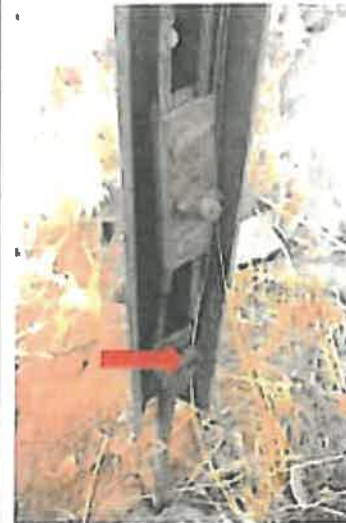
**" Must have
12 inches
Vertical
Clearance or
use
Insulators"**

Exhibit "G"; is a copy of the SCE standard I provided the CPUC and Cal Fires separating the connection point on the pole by 12" which is another method to

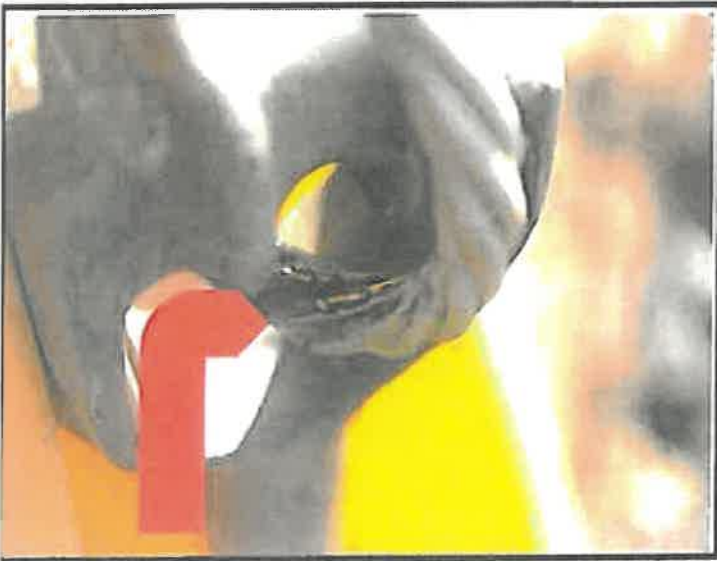
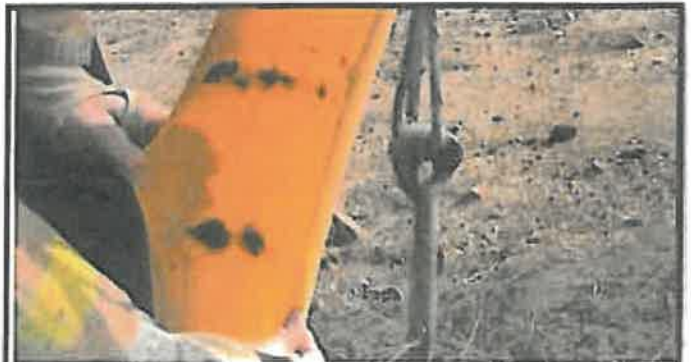
Dry Grass at
Point of
Arcing

Lab Reports show the following:
O.C.St.Fe.Zn.Al.Ca.Mg.K. i
Note: This particular sample was from the "CEDAR FIRE"
Lab results show high contents of Carbon from ARCING

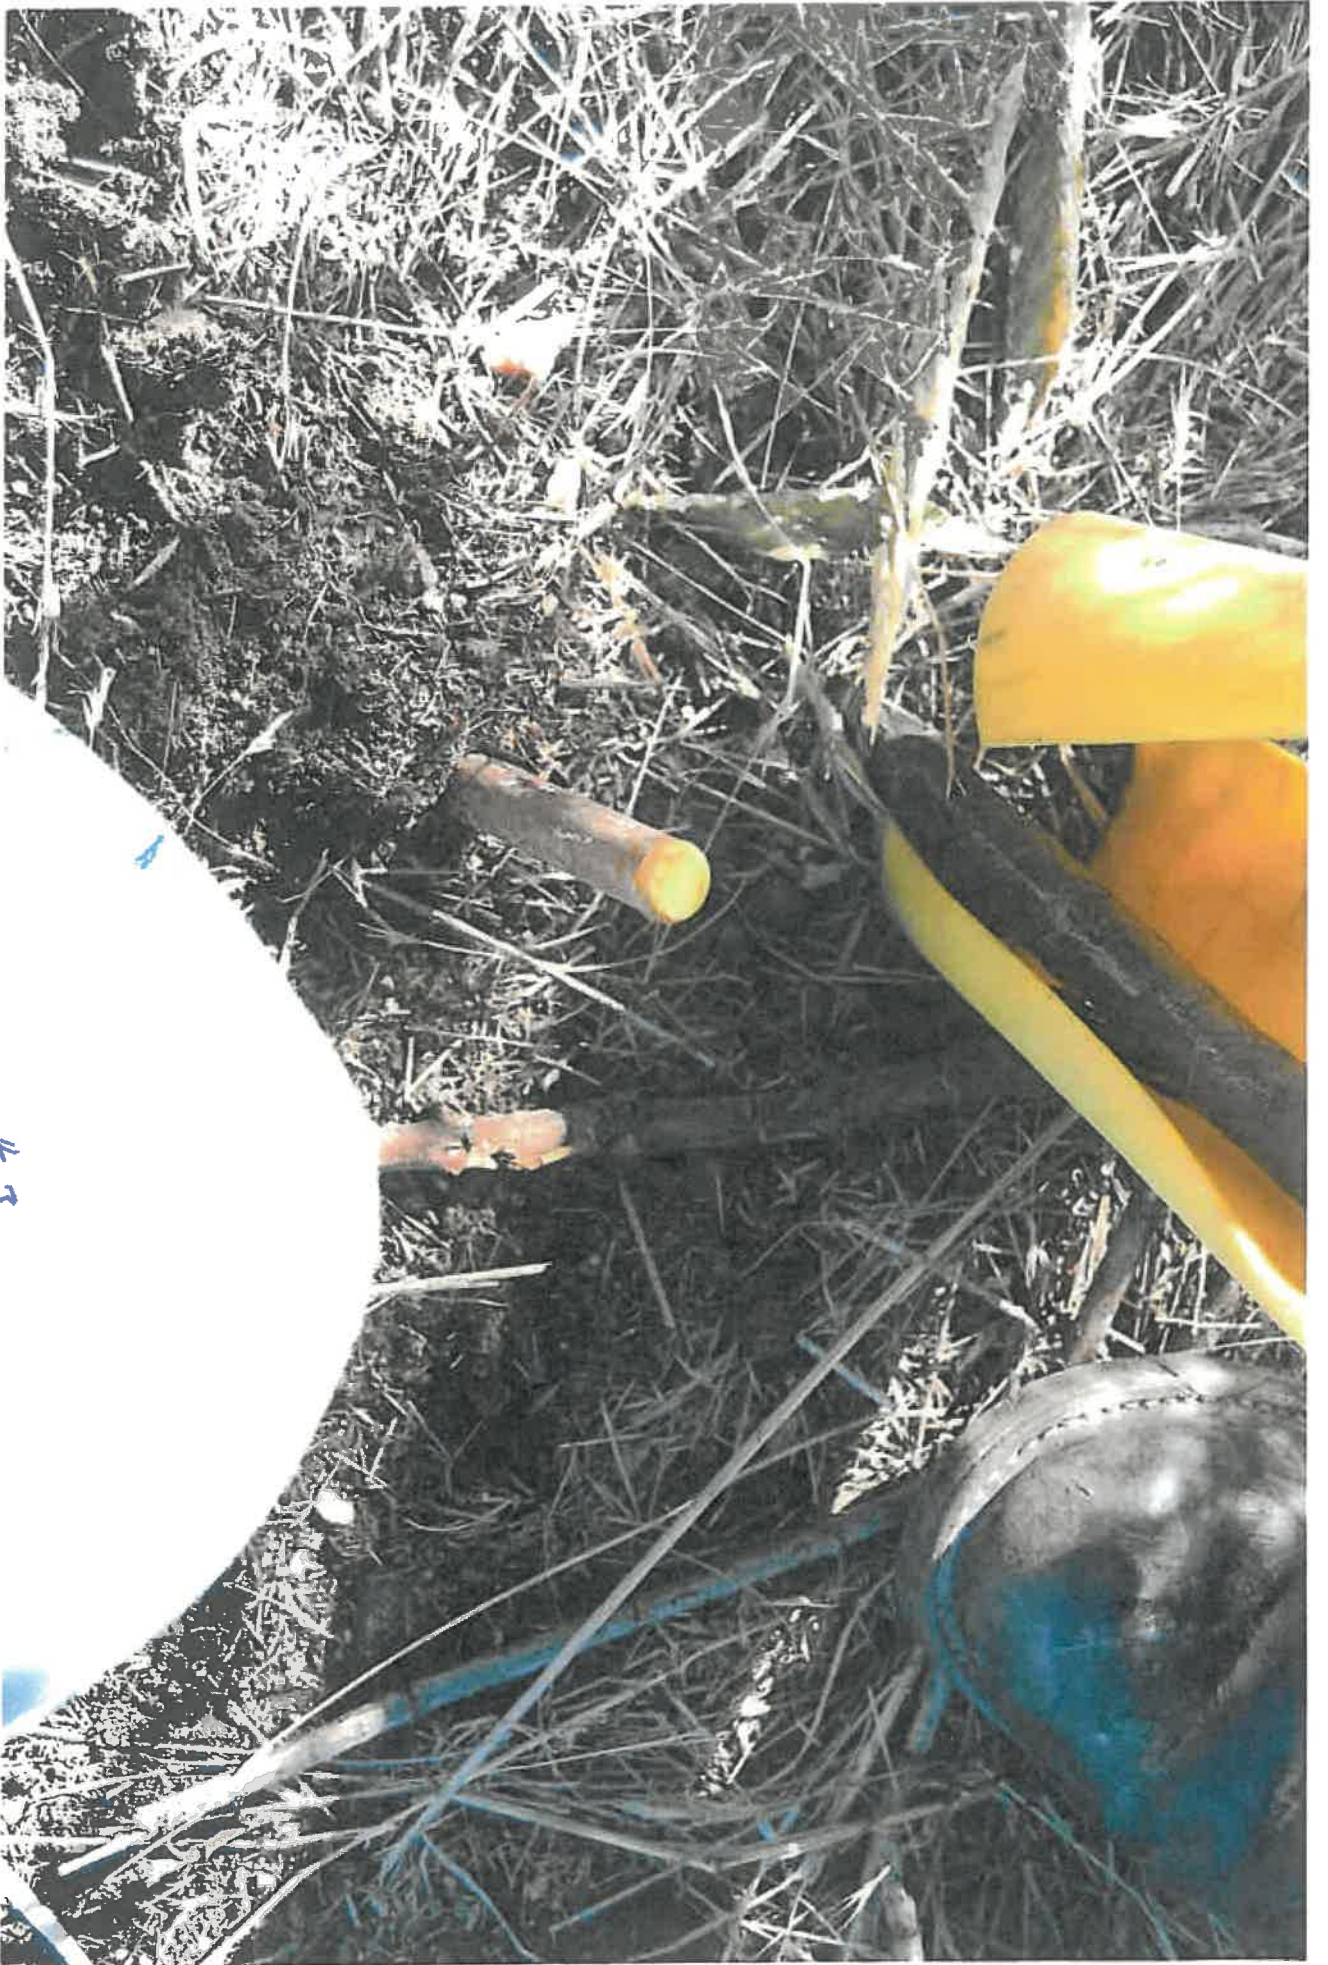
Exhibit “D”

Exhibit "D": Is a picture of the bare anchor rods and provided to the PUC and showed during inspection. The anchor rod exists in multiple locations but does not have attachment to ground guy wire to effectively ground as required by their own design standard provided to CPUC in 2008 that SDG&E issued in 1999.. It appears that the intent was to ground, and after installing the ground rod, know body came back to add he remainder of the kit. Thus allowing 2003 paradise, Cedar and 2007 Witch Creek fire. PG&E territory has nothing to ground the down guy properly

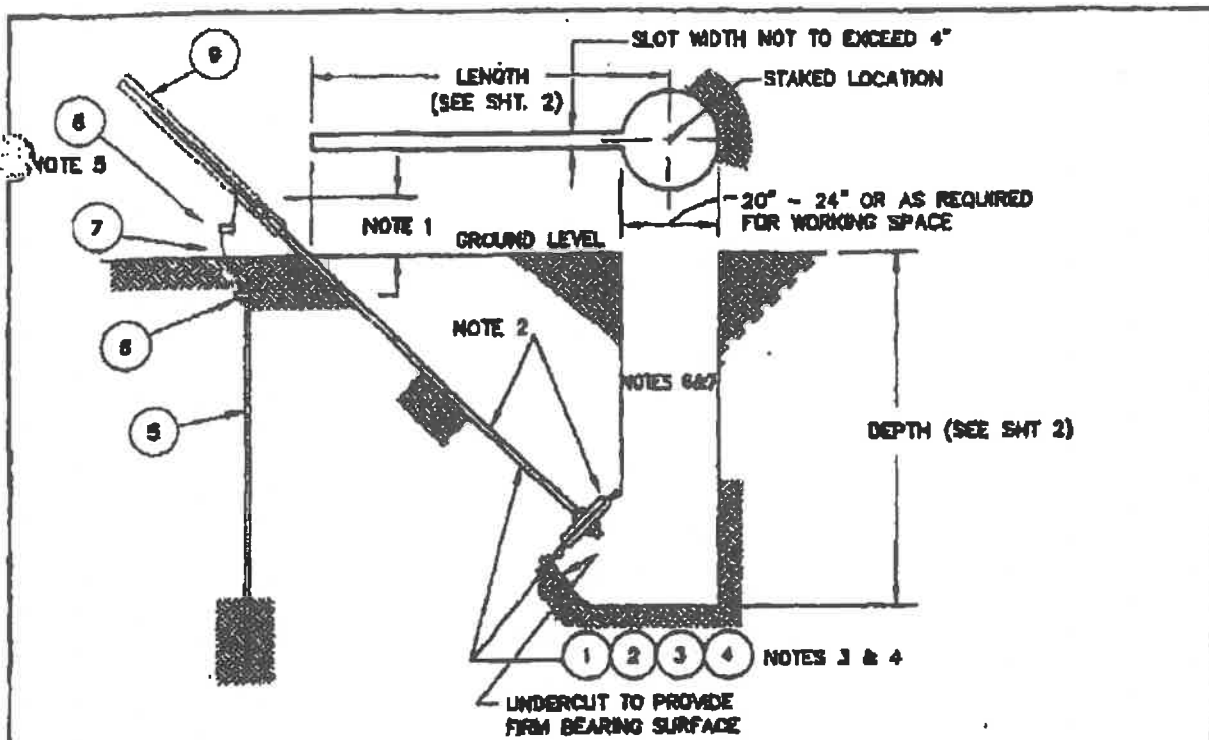
Exhibit “E”

Exhibit "E": Is the SDG&E Standard originally issued 8/1/1999 that shows proper installation of how to connect and shunt the connection point to prevent arcing, thus properly grounding the down guy wire.

1. IN AREAS WHICH HAVE DRIFTING SAND, EYE OF GROUND ROD SHALL BE INSTALLED 12" ABOVE GROUND LEVEL. ELSEWHERE 6" IS SUFFICIENT.
2. PROTECTED ANCHOR AND ANCHOR RODS ARE FURNISHED SEPARATELY BY STOREROOM. THEY WILL BE ISSUED AS A KIT TO BE ASSEMBLED AT THE JOB SITE.

NOTE that this SDG&E standard was developed before the 2003 Paradise, 2003 Cedar fires and the 2007 Witch Creek fires. Unfortunately, was not properly utilized on the 2003 Paradise and Cedar and 2007 Witch creek fire locations on their down guy attachments, thus starting fires. . I showed the CPUC and Cal Fires pictures and in person how and why these fires started and neither organization published the information in their reports made public.

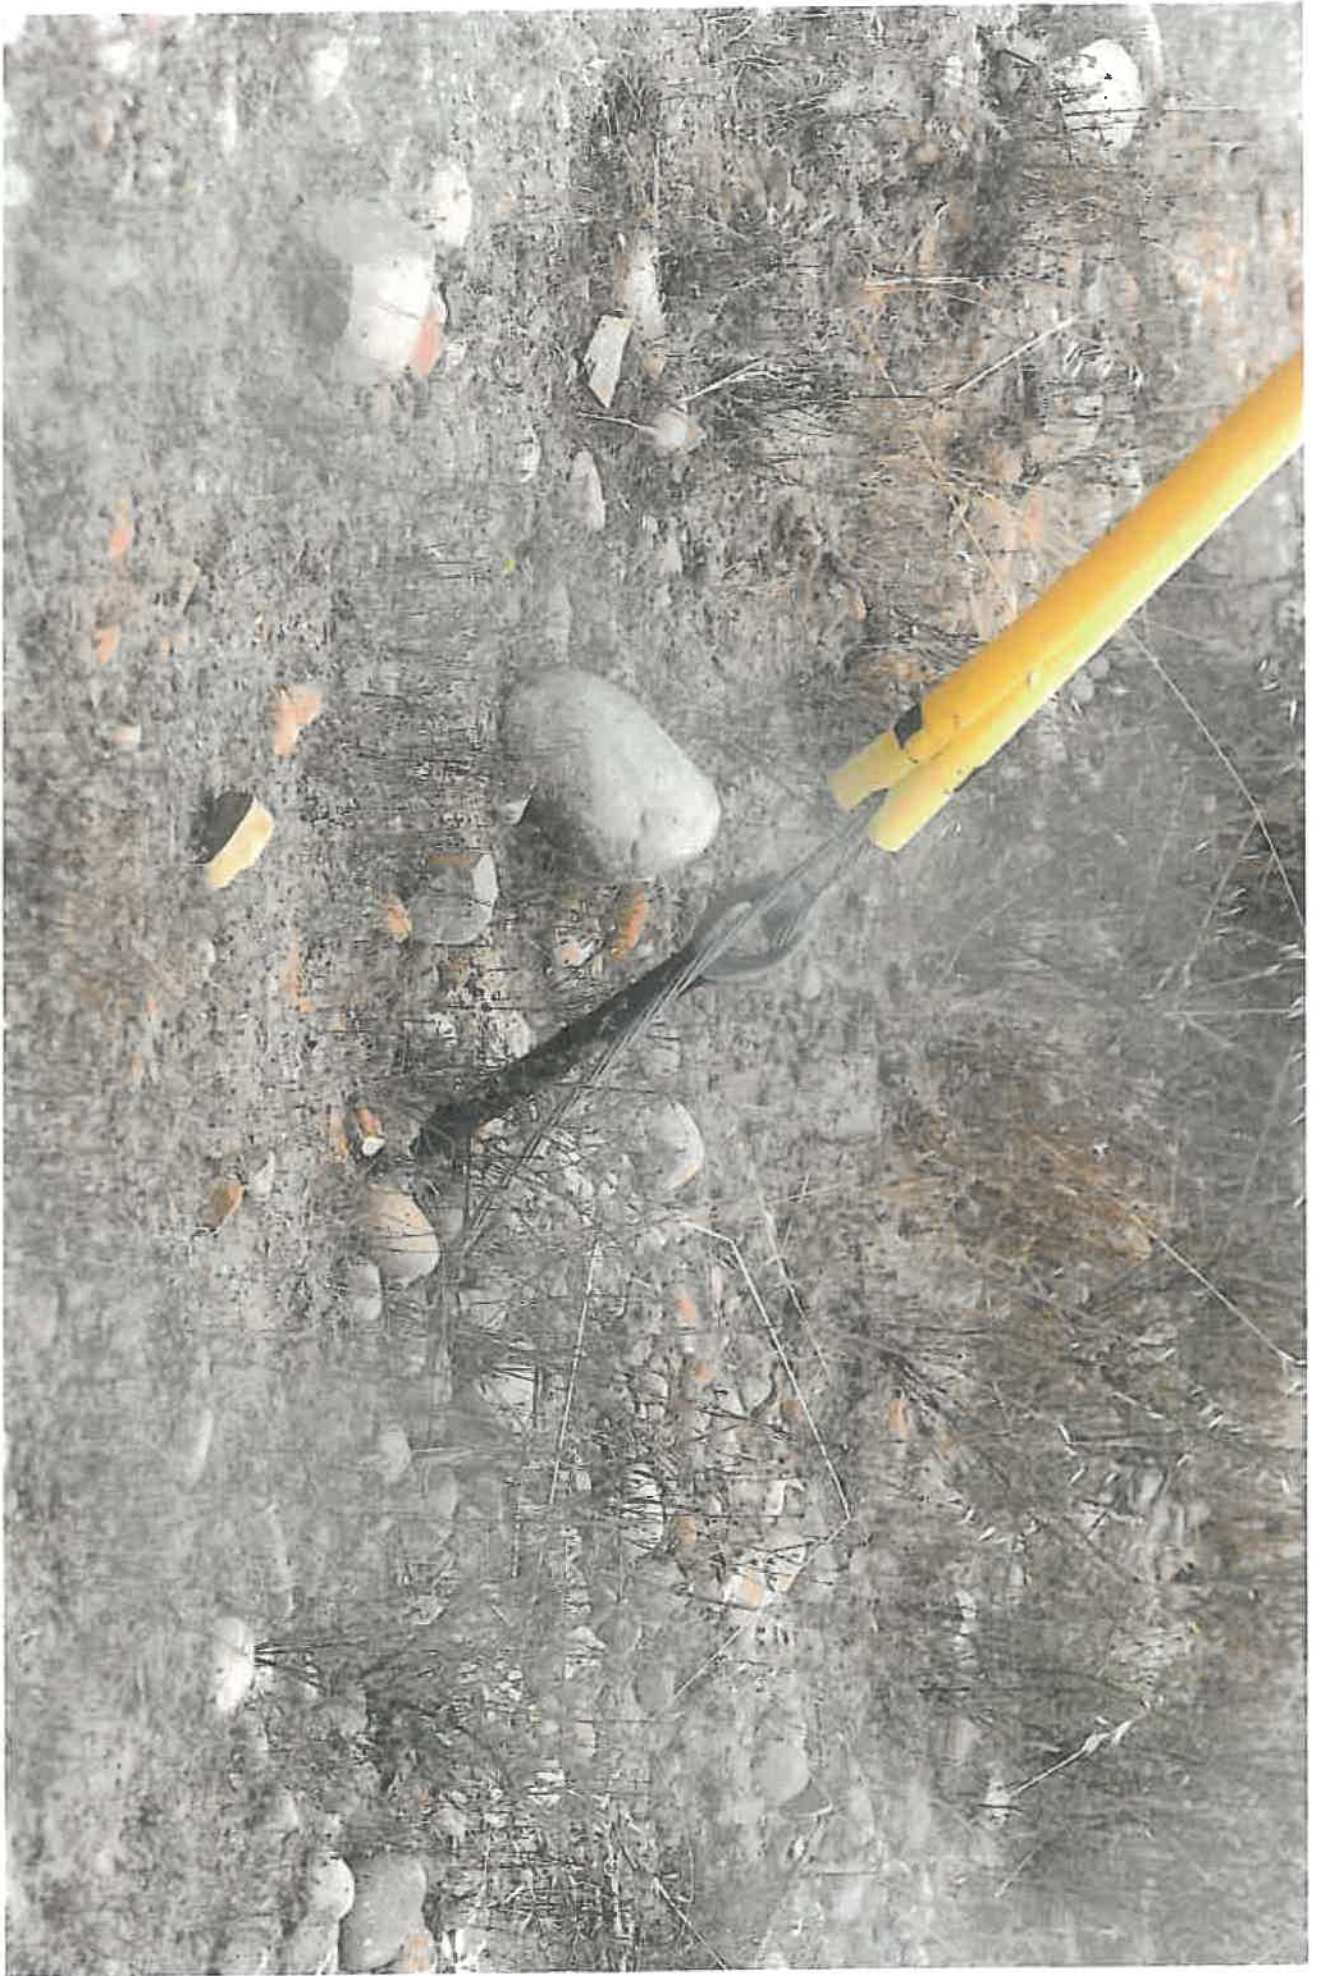
1#

Is a picture of another SDG&E location I took showing the proper Installation to ground a guy wire to prevent arcing at ground level to be consistent with the standard.

PICTURE 1: Shows the pigtail from down guy left long enough to attach to a separate ground rod.

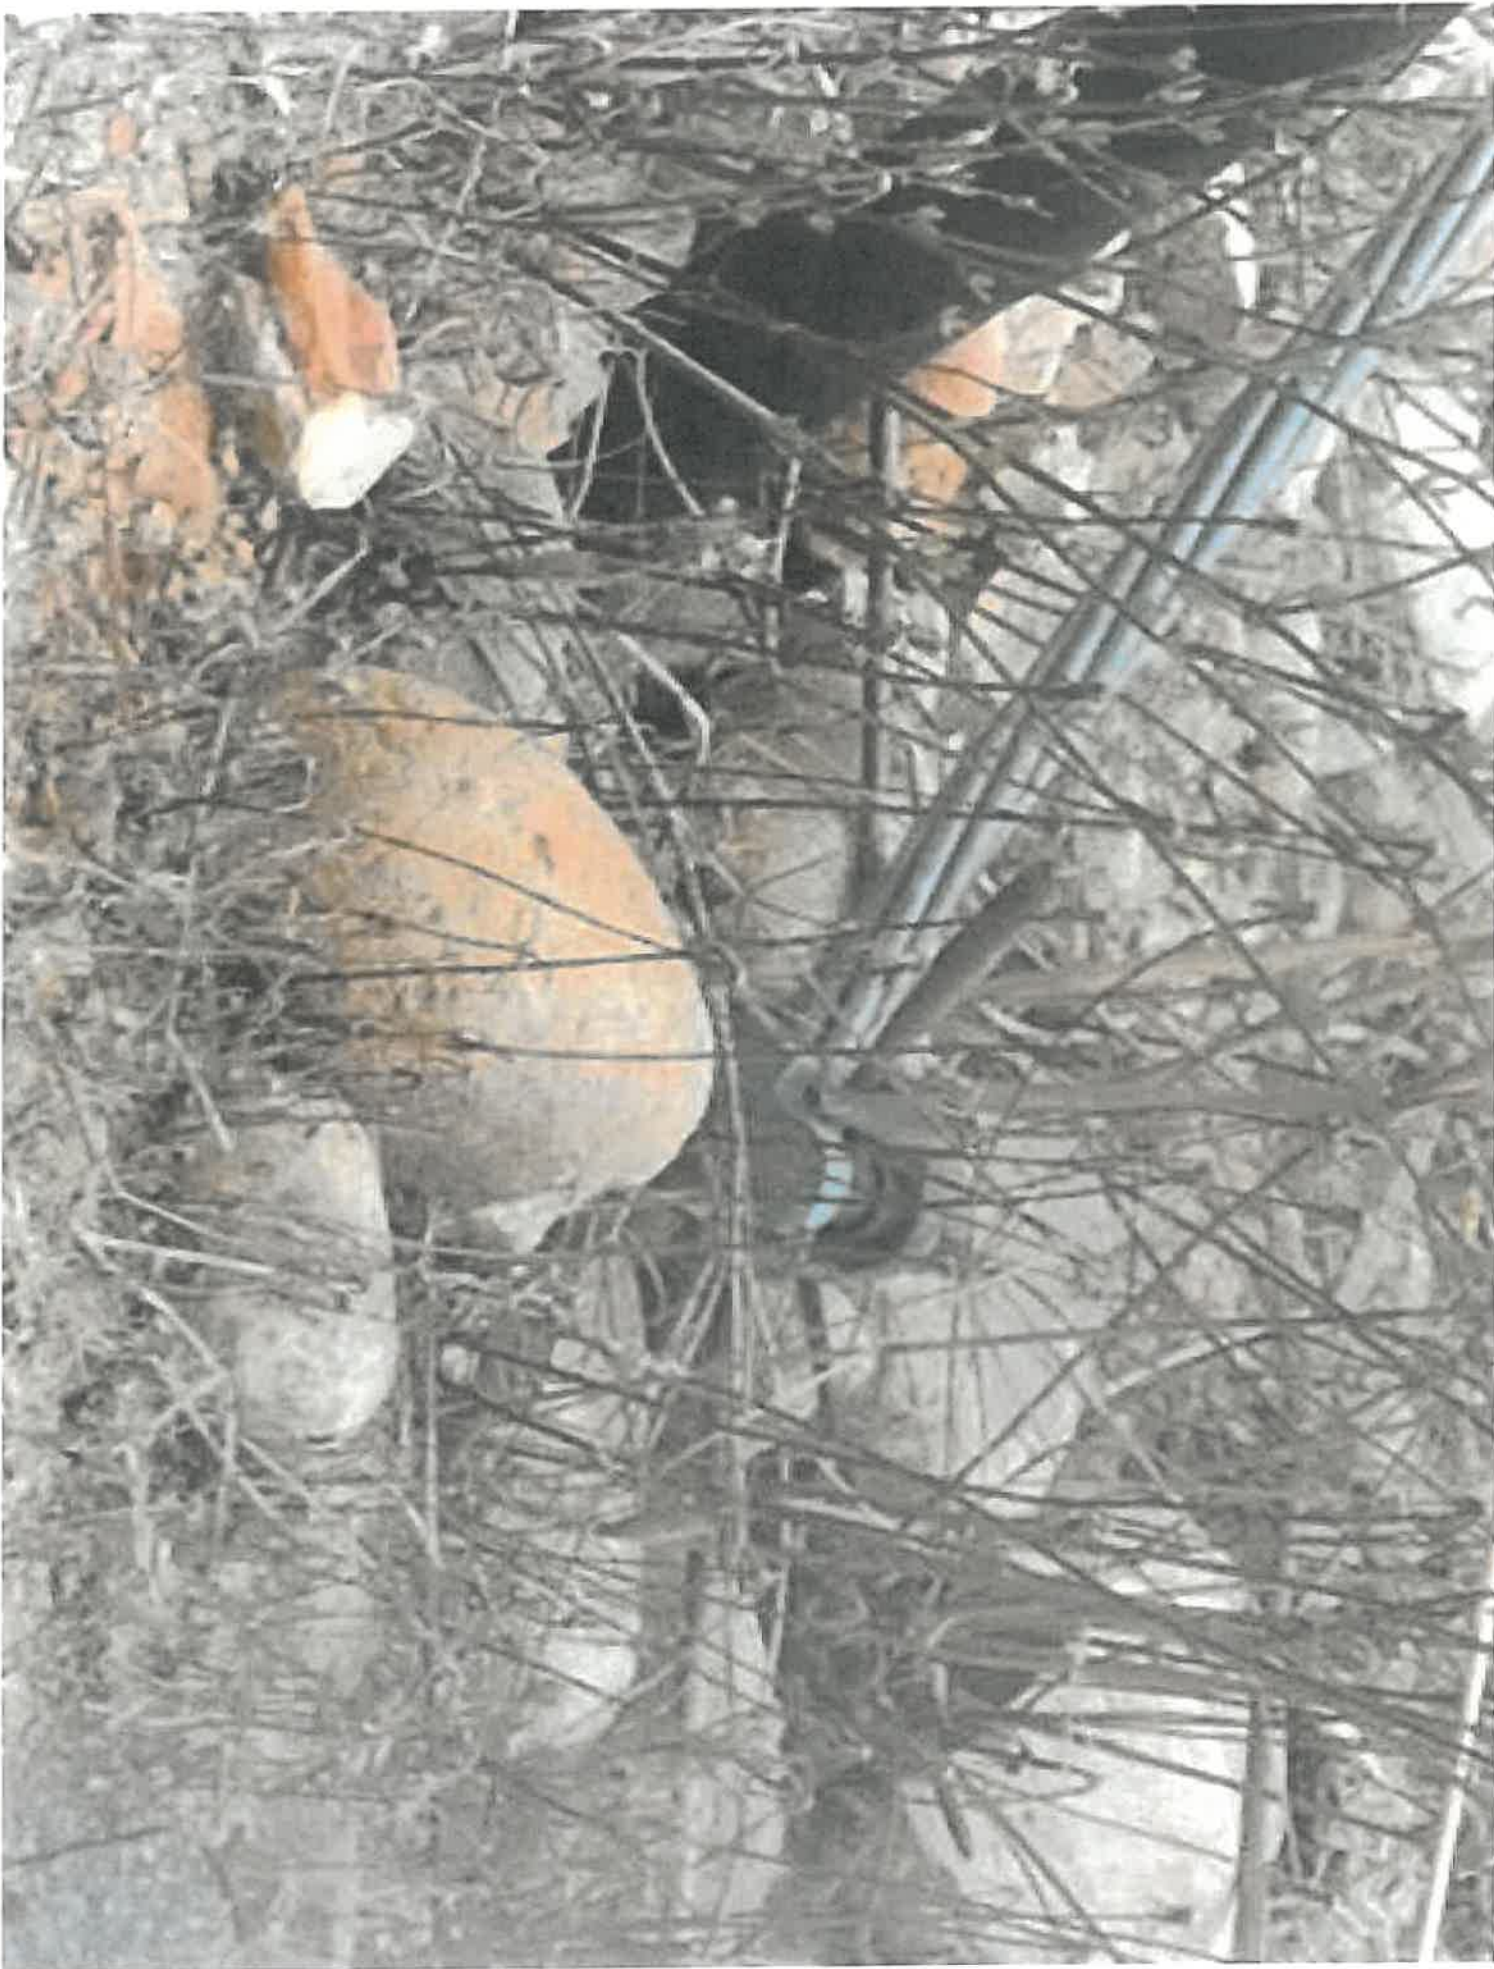
Picture 2: Shows a close up of connection to separated ground rod consistent with SDG&E standard issued 8/1/1999

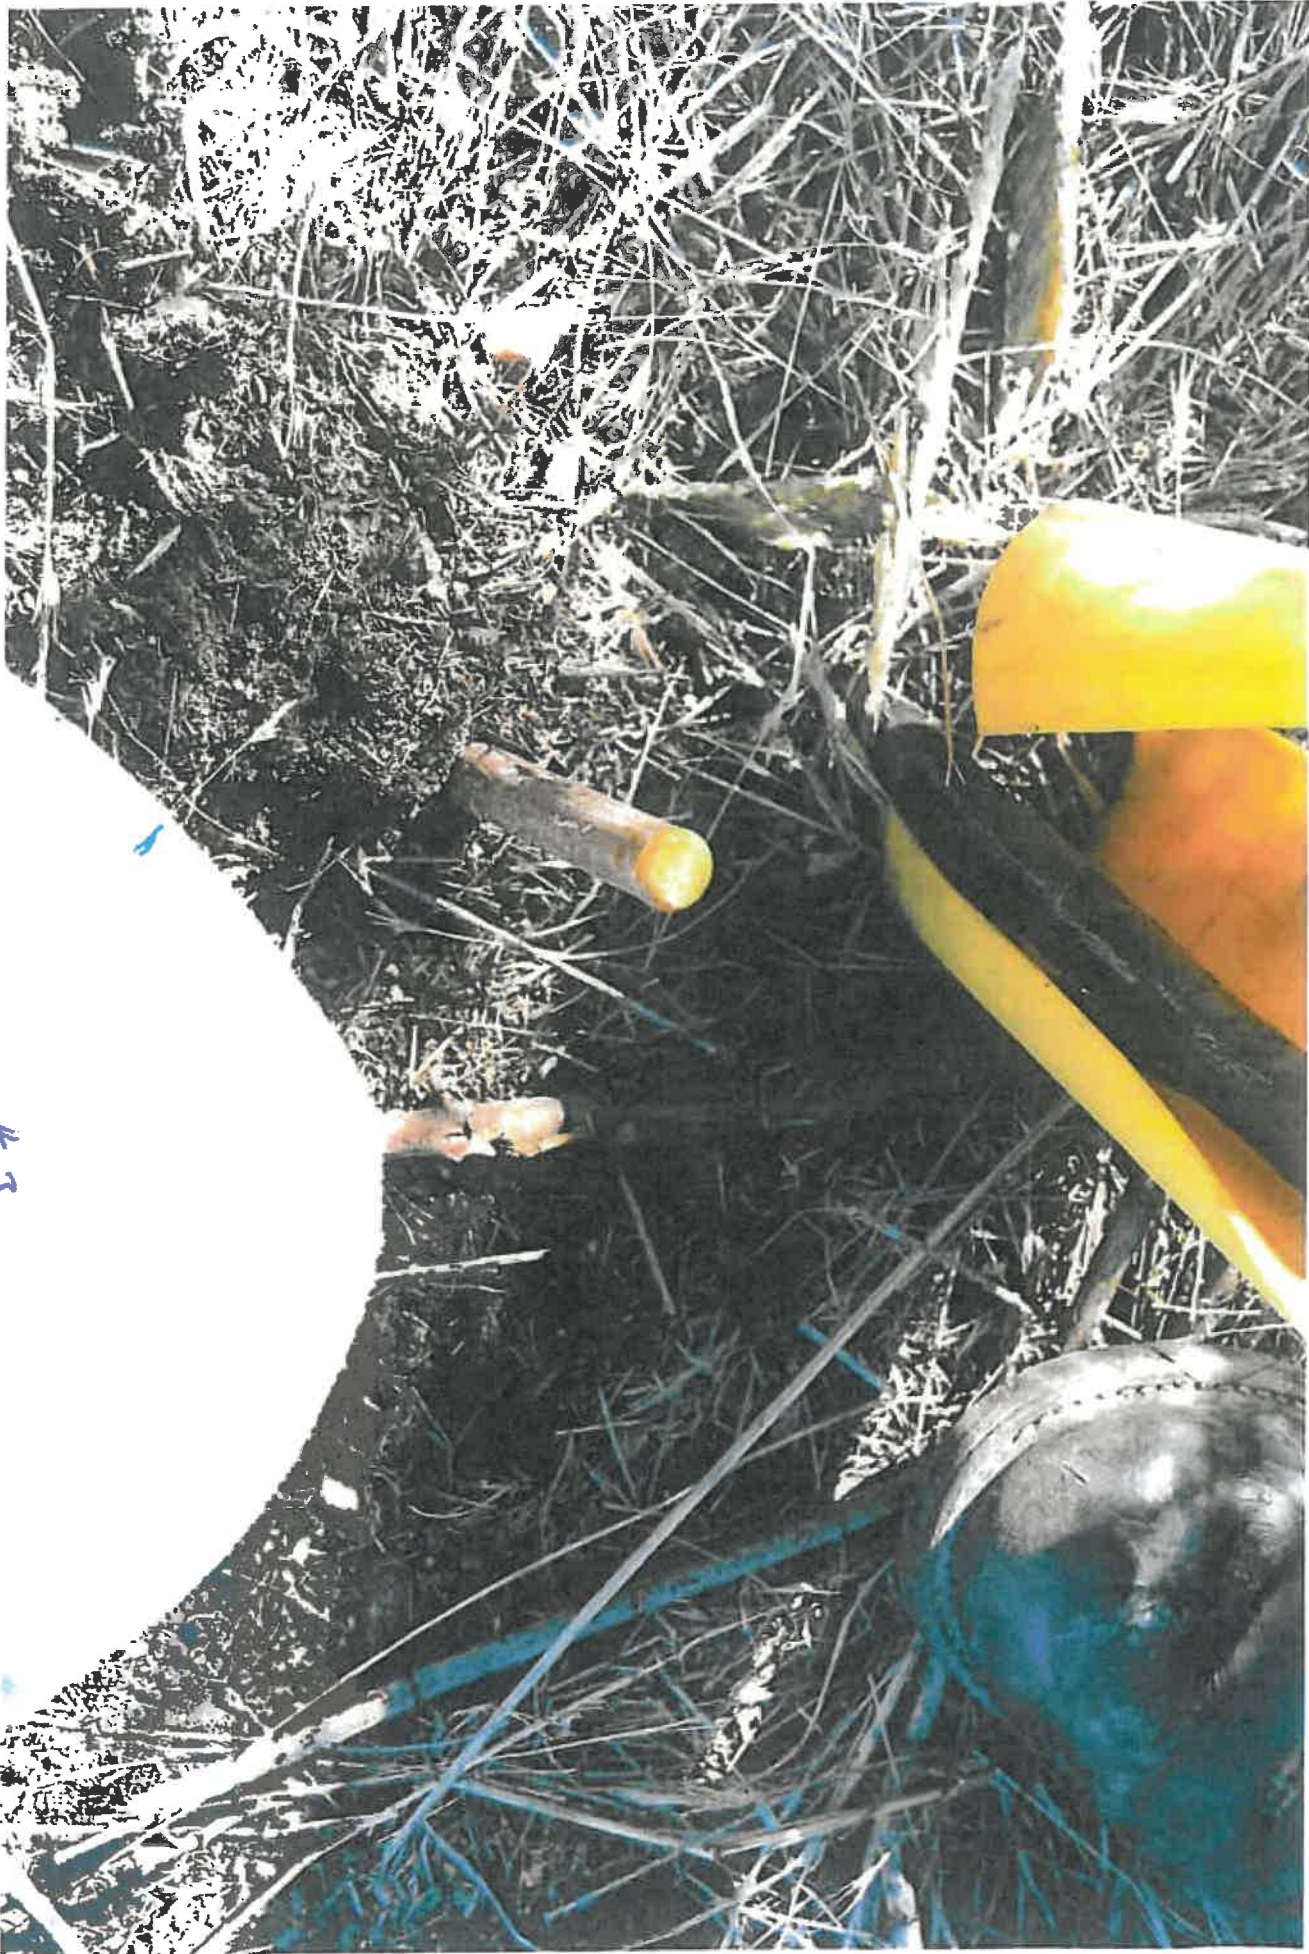
#3

Picture 3. Picture I provided CPUC in 2008. Note ground rod next to down guy anchor without any connection from down guy as required by standard issued in 1999. The failure to make this connection is what started the 2003 Cedar and Paradise fires an the 2007 Witch Creek Fire in San Diego..

NOTE: SDG&E made an attempt and drove a ground rod and just did not finish the job resulting in the 2003 cedar, paradise and 2007 Witch Creek Fire. THE ENTIRE PG&E SYSTEM IS WITHOUT GROUNDING ON DOWN GUYS. Hence the start and spreading of the Northern California Fires dangerous conditions still exist today.

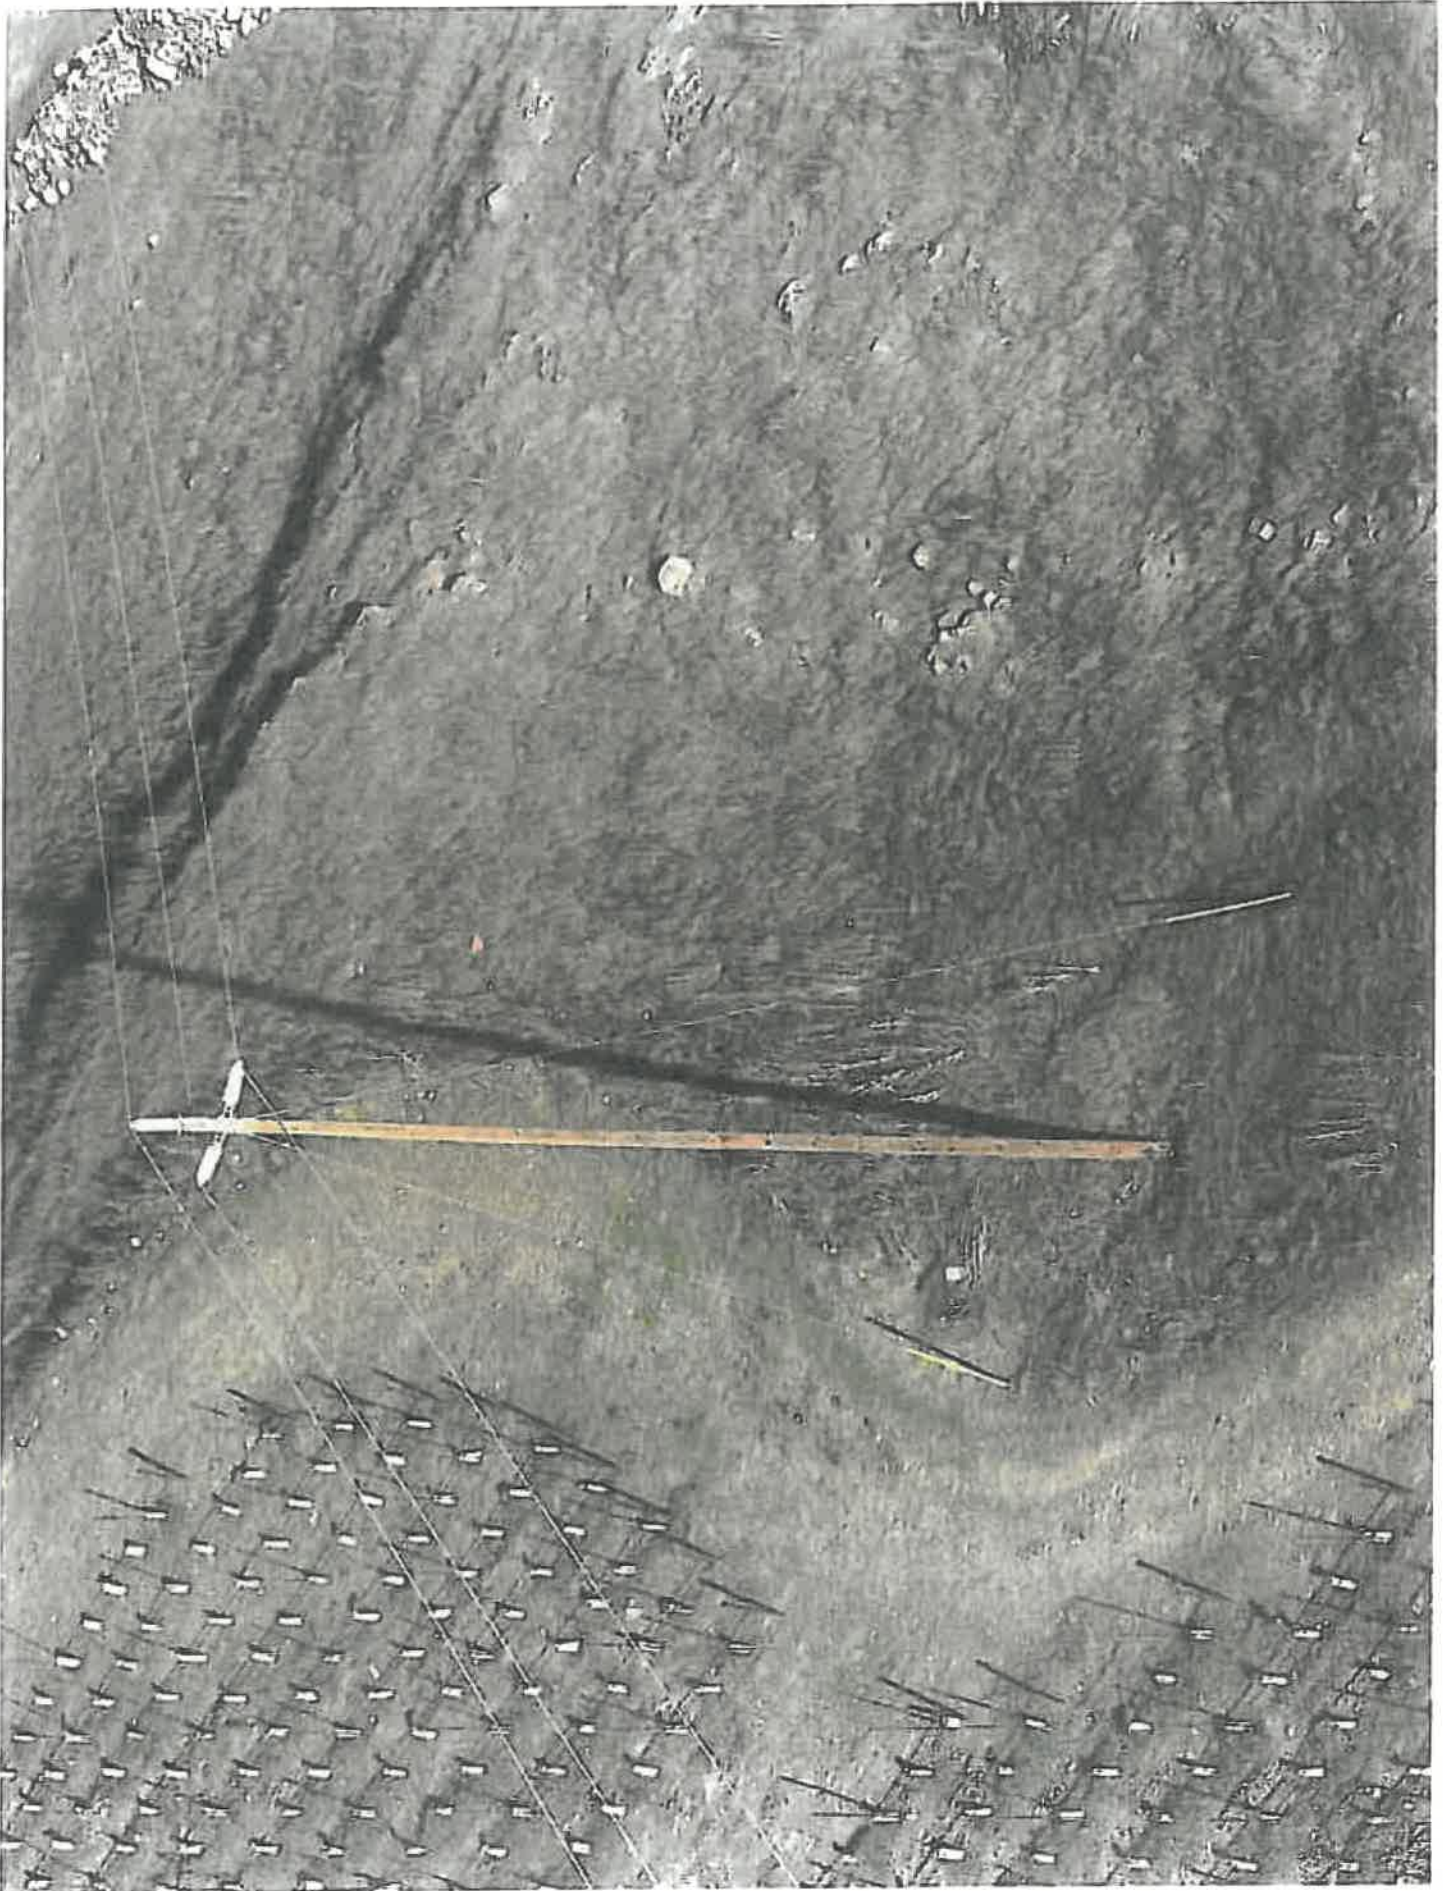
Exhibit “H”

Exhibit "H": Is an aerial picture from my investigating the 2017 Northern California Fires I provided you, showing a fire originating and starting at a down guy anchor just like in San Diego 2007 Witch Creek Fire

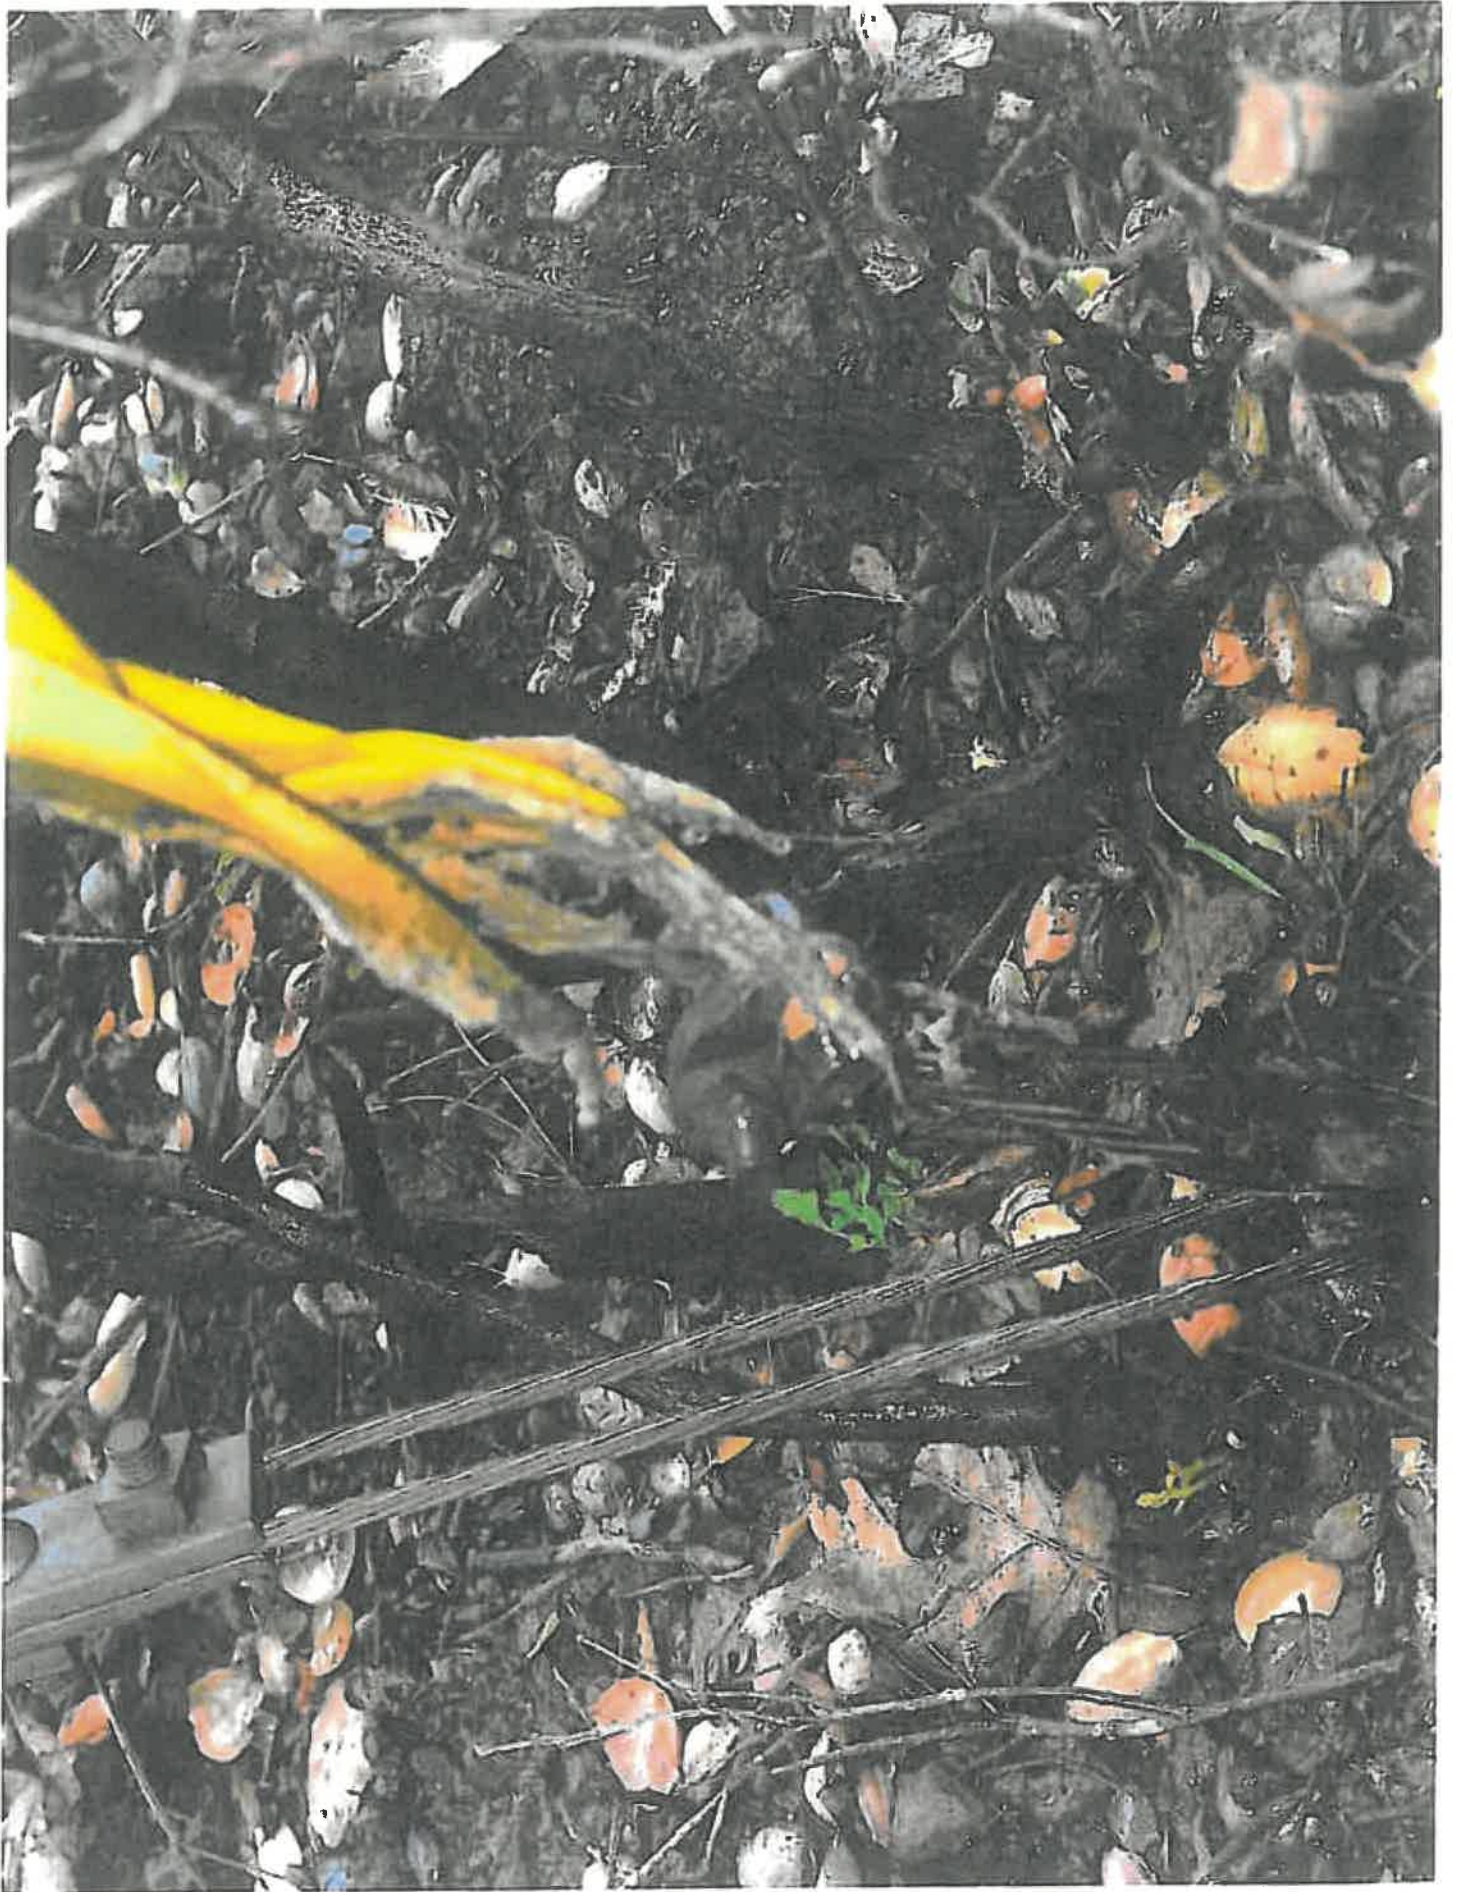
Exhibit "I"

EXHIBIT "I" is another photo I showed you where fire originated on the Tubbs fire caused by the same down guy design on PG&E system.
